USING OF NON-DESTRUCTIVE TEST OF ACCOUSTIC EMISSION FOR PROLONGING THE OPERATION LIFE OF COMPOSITE PRESSURE CYLINDERS

Review article

Abstract: Financial crisis in the years 2008 to 2013 had a negative effects also in a state administration, and as well in a purchase, renewing and services of technical means of fire protection. Under the terms of School educational and vocational establishment of the Fire and Rescue Service of the Czech republic (FRS CR), center in Frydek - Mistek, this condition was fully displayed at the FRS CR at the state of composite pressure cylinders (PCs), that are from the point of view of operation of the breathing apparatuses, and other technical means such as bags, sealing means, means for works on water, that are inevitable for their operability. In this article prolongation of an operation life of PCs is described, on the basis of supplementary nondestructive acoustic emission testing (AT), that is a part of hydraulic pressure test. In conclusion it is written the state of PCs after the operation life having been prolonged and before their final decommissioning.

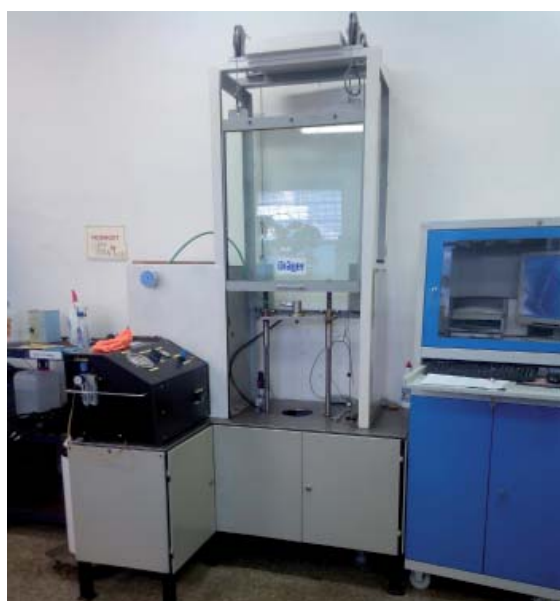
Fig. 4 Pressure box by Dräger Safety company

- after the assessment of the condition of the PC (on the basis of mechanical a heat failure), disassembling of the cylinder valve and its checking, inside revision of the PC was carried out and a screw thread connection of the valve revision was carried out as well by a screw gauger.
- PC was put into the pressure box, *as it is shown in Fig. 4*,

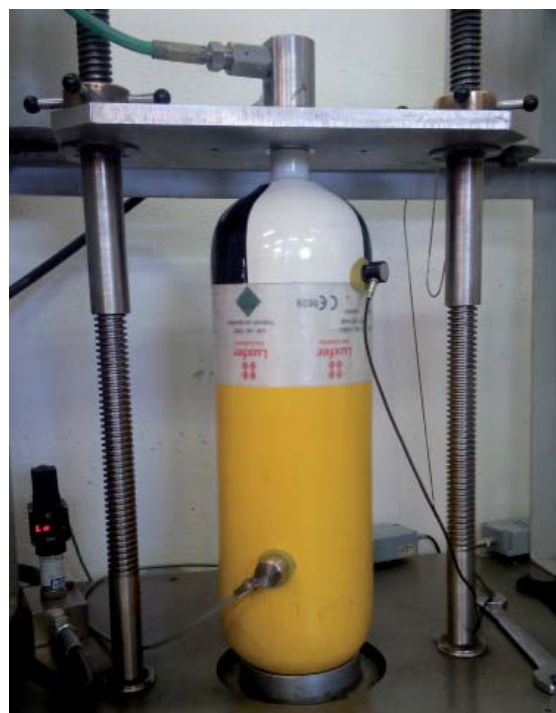
Fig. 5 Position of the PC at the testing device of Dräger Safety company.

- two piezo electric sensors were put in cross by plasticine onto a cylindrical, cleaned surface of PC, *as it shown in Fig. 5*,
- check of the signal transmission of the system and its interconnection with software was carried out,
- initial pen-test was carried out (source Hsu-Nielsen) - mne, $\varnothing 0,5$ mm, 2H between the sensors, for the calibration both of seven-level sensors,
- PC was attached to pressurizing device and then it was pressurized up to test pressure,
- the final pen-test was carried out after depressurizing and then the calibration was carried out again,
- duration of pressurizing and frequency of ring down counts per second (P/s) were graphically recorded and the data was recorded to the testing protocol to its assessment and later printing.

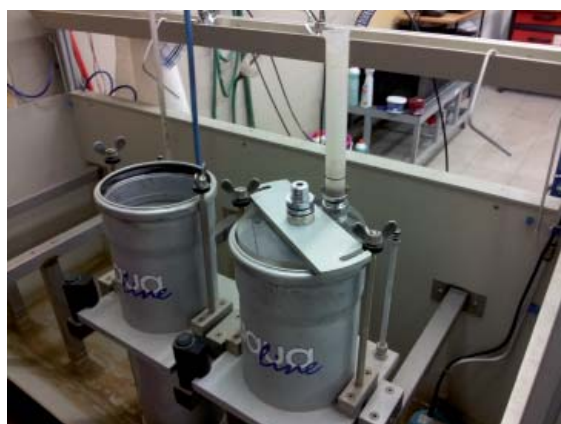
Fig. 7 Test device for hydraulic pressure test and for the test of volume expansion of PCs at Repair plant of FRS CR in Olomouc

After expiring the prolonged operation life of PCs, there was a unique possibility to carry out the final revision of these cylinders in cooperation with the Repair plant division of FRS CR in Olomouc, see Fig. 7, before their definite putting out of operation or another prolongation of their operation life. The intention of that was to carry out a periodical revision of PCs in order to find out their real state and to have a sample and data for same cases in future. The conclusions of this assessment are dated in table.
